Microbiological Activity and the Deterioration of Water Well Environments on the Canadian Prairies

Twyla Legault

Prairie Farm Rehabilitation Administration - Agriculture and Agri-Food Canada
Regina, Canada

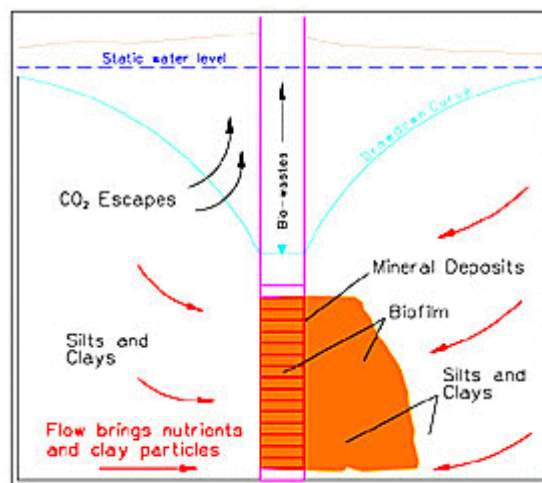
Figure 1: Water Well Biofouling

Biofouling of a water well occurs when biofilms accumulate a sufficient amount of debris to interfere with water flow and affect water quality. Installing and pumping a well increases the level of oxygen and nutrients in the well and surrounding

aquifer. This encourages bacteria to colonize surfaces in and around the well intake. The bacterial colonies will form a gel-like slime or biofilm that captures chemicals, minerals and other deposits such as clays and silts, that move to the well during pumping. Some of the byproducts associated with bacterial growth, such as iron and manganese, will also become accumulated in the biofilms (Legault, 1999).

If uncontrolled, well biofouling can affect well performance in various ways. Biofilms and the debris they collect can quickly coat, harden and plug the well screen, the sand pack, the surrounding aquifer material and may even plug water lines and affect the performance of household treatment systems. In addition, the bacteria living within the biofilm can increase the rate of iron oxidation increasing iron build up, which may lead to occasional discoloration of the well water. (Legault, 1999).

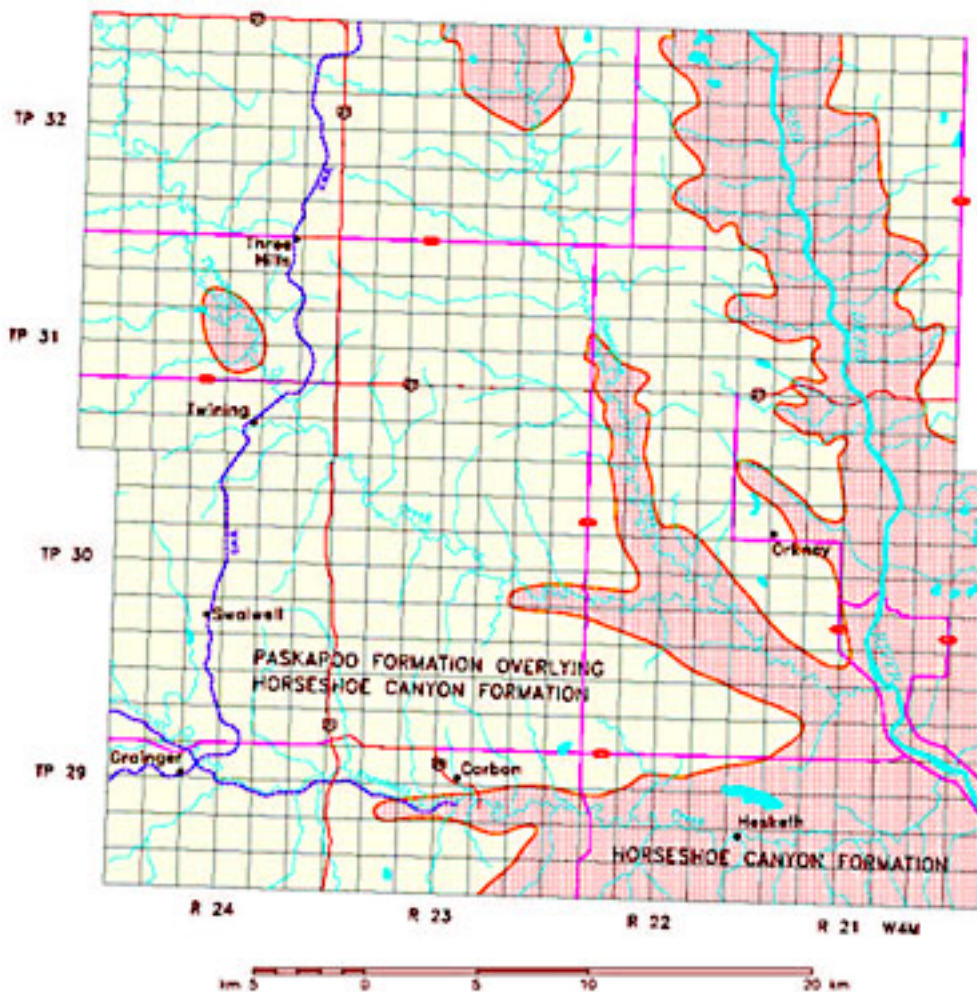
The uppermost bedrock formations, the Horseshoe Canyon and Paskapoo, are composed of layers of sandstone, shale and coal. Where it exists, the Paskapoo Formation overlies the Horseshoe Canyon Formation (see figure 2).

The Paskapoo formation is coarse grained with some thick sandstone lenses. In contrast the Horseshoe Canyon Formation is generally fine grained and has a high bentonite content which leads to low water supply potential. "Lineaments" are present throughout the area and are thought to represent surface expressions of fracturing in the underlying bedrock. A gas field is known to lie below the Horseshoe Canyon Formation in the south-eastern portion of the study area.
